# When one or two Bumpers DO NOT Fit

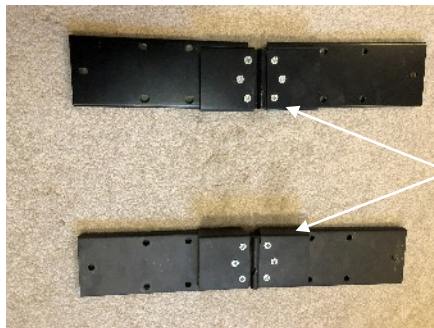
If the table is correctly assembled, all the bumpers should fit nicely down to the table surface. If they do not, it is caused by one or more table hinge assemblies being mounted incorrectly. Each of the hinge assemblies are made with the top portion offset from the body of the hinge by about one-half inch. This offset is to provide an adequate space for the extension on the bottom of the bumper. The hinges should be mounted with the offsets located facing each other to provide this adequate space.

NOTE: OFFSET

NOTE OFFSETS

To correct this problem, just unbolt the offending hinge(s), rotate them to provide the proper offset, then remount them to your table. This is done most easily by opening the table but don't put on the bumpers. Locate the offending hinge(s) and unbolt from the table, rotate it 180 degrees, and re-attach. Do this for all hinges as needed, one at a time. This photo shows the correct orientation for the pair of hinges on a table.
