WHEN ONE OR TWO BUMPERS DON'T FIT

When one or two Bumpers DO NOT Fit

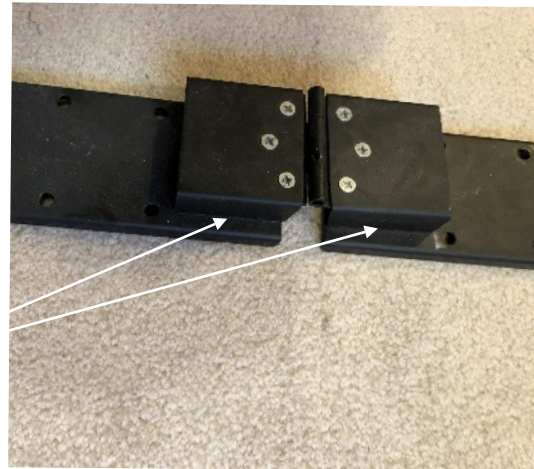
NOTE: OFFSET

If the table is correctly assembled, all the bumpers should fit nicely down to the table surface. If they do not, it is caused by one or more table hinge assemblies being mounted incorrectly. Each of the hinge assemblies are made with the top portion offset from the body of the hinge by about one-half inch. This offset is to provide an adequate space for the extension on the bottom of the bumper. The hinges should be mounted with the offsets located facing each other to provide this adequate space.

To correct this problem, just unbolt the offending hinge(s), rotate them to provide the proper offset, then remount them to your table. This is done most easily by opening the table but don't put on the bumpers. Locate the offending hinge(s) and unbolt from the table, rotate it 180 degrees, and re-attach. Do this for all hinges as needed, one at a time. This photo shows the correct orientation for the pair of hinges on a table.

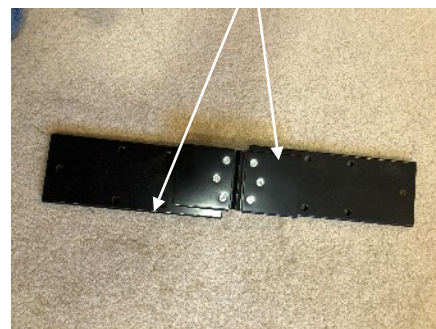
OFFSETS

If you have a hinge with opposed offsets as in the photo to the right, call Poly Pong to get a placement.
