WHEN ONE OR TWO BUMPERS DON'T FIT

When one or two Bumpers DO NOT Fit

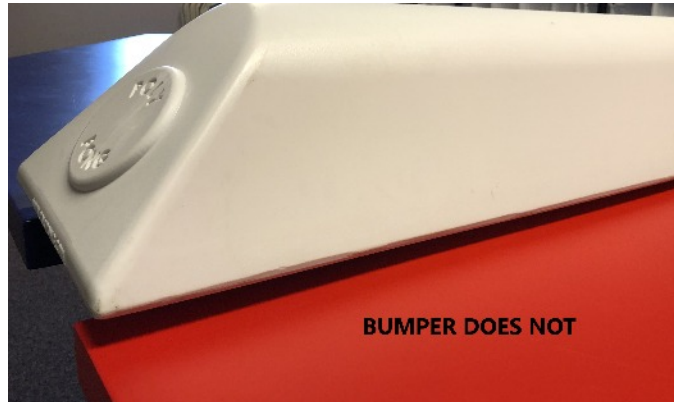
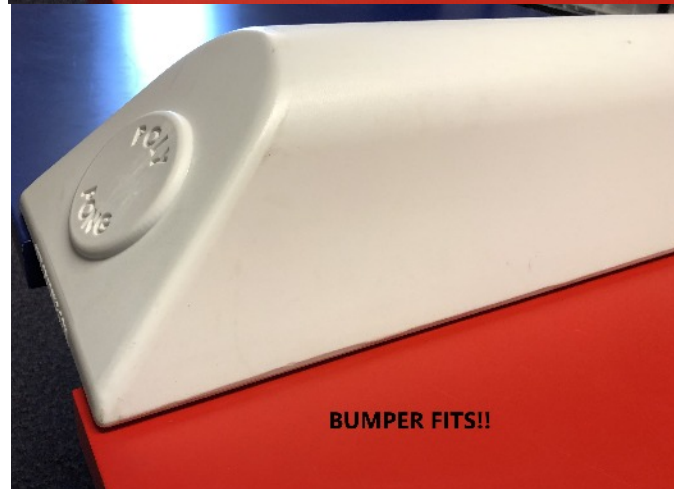
If the table is correctly assembled, all the bumpers should fit nicely down to the table surface. If they do not, it is caused by one or more table hinge assemblies being mounted incorrectly. Each of the hinge assemblies are made with the top portion offset from the body of the hinge by about one-half inch. This offset is to provide an adequate space for the extension on the bottom of the bumper. The hinges should be mounted with the offsets located facing each other to provide this adequate space.

To correct this problem, just unbolt the offending hinge(s), rotate them to provide the proper offset, then remount them to your table. This is done most easily by opening the table but don't put on the bumpers. Locate the offending hinge(s) and unbolt from the table, rotate it 180 degrees, and re-attach. Do this for all hinges as needed, one at a time. This photo shows the correct orientation for the pair of hinges on a table.

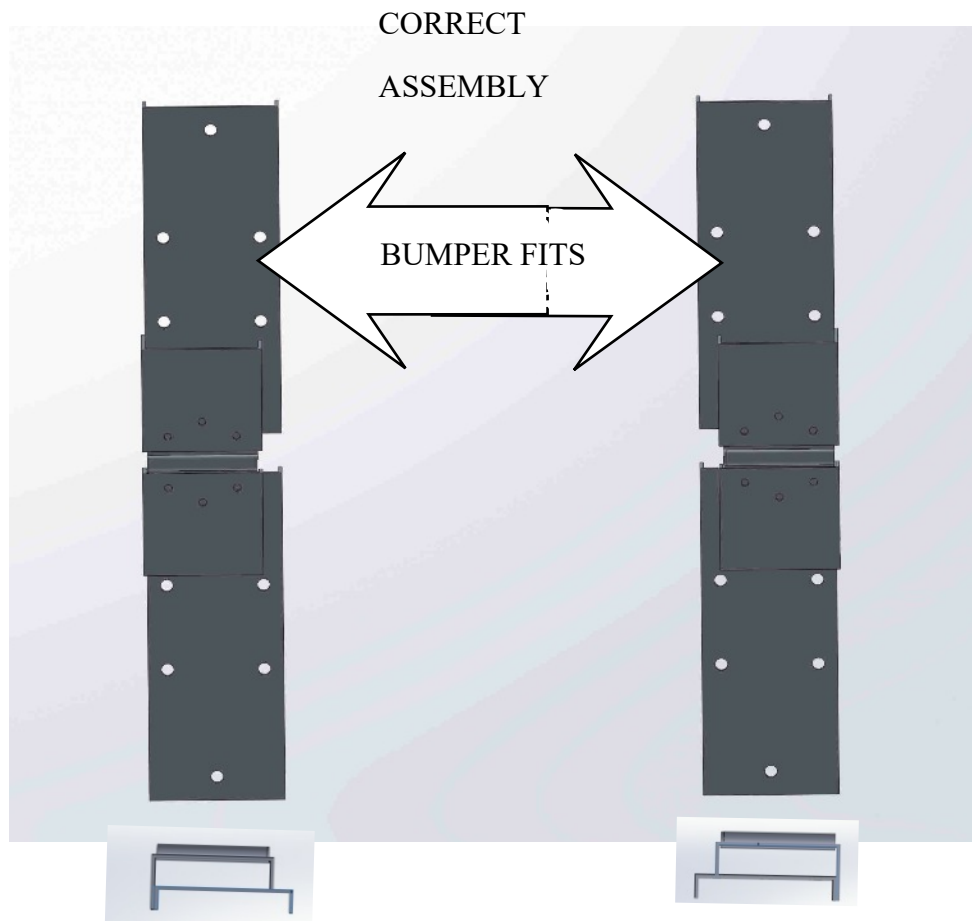
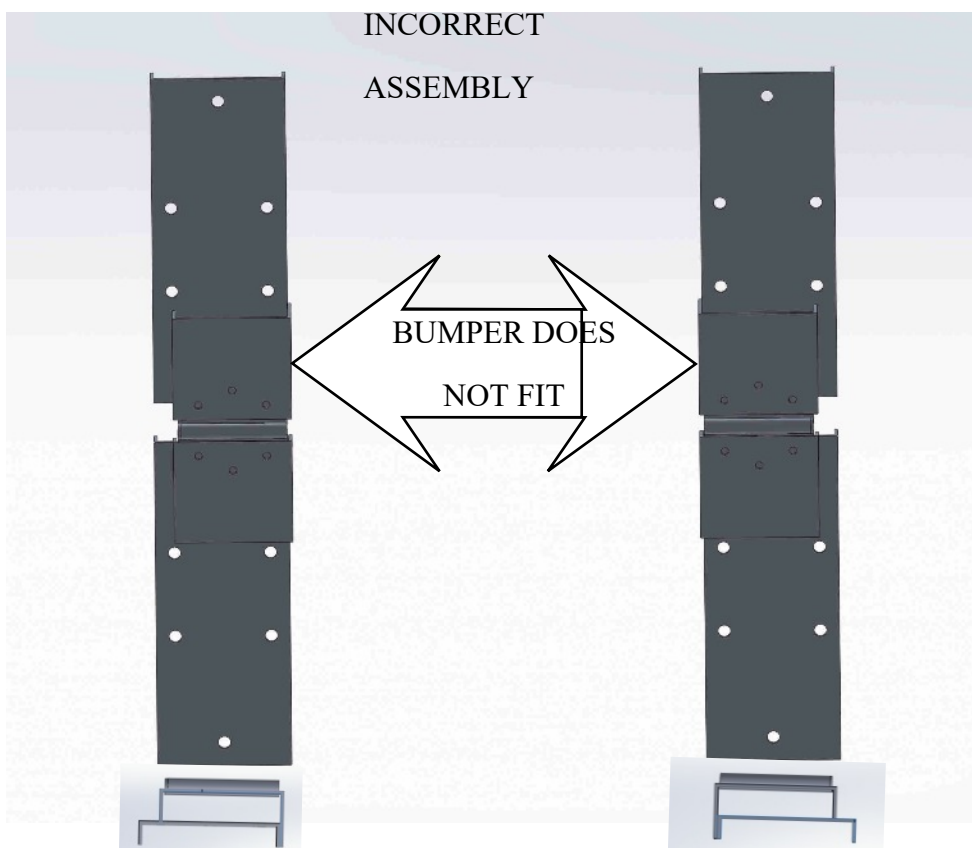
NOTE: If the bumpers do not fit down tight on the table, check the hinges.
